# Manhole Inspection Summary

Manhole # S21C1\_005MH

Insp Date: **5/21/08 10:31 AM**

**Location** Address: **2508 paca st**

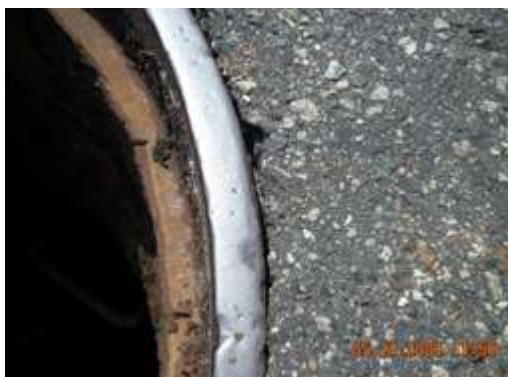
Defect 3

☒ **Leaks**

frame leaks @ separation from asphalt

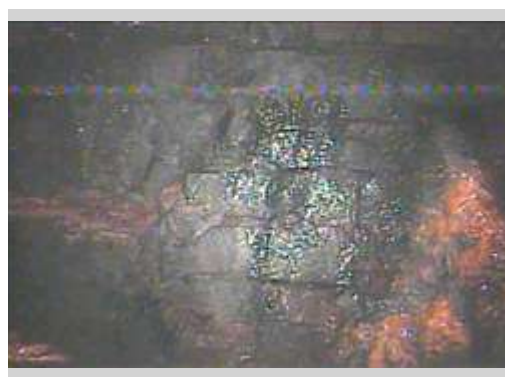
Defect 2

Infiltration: ☐ None ☐ Joint ☐ Cracks ☐ Mortar ☐ Roots ☒ **Wall**

infiltration @ barrel wall

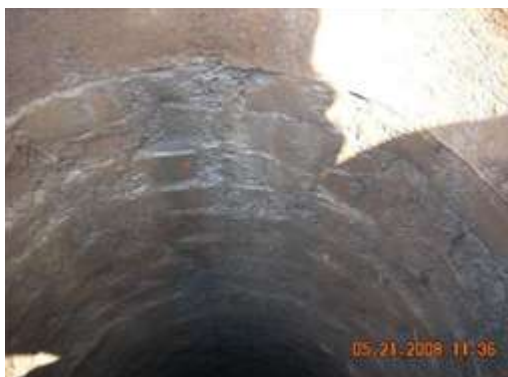
Defect 1

Infiltration: ☐ None ☒ **Joint** ☐ Cracks ☐ Mortar ☐ Roots ☐ Wall

infiltration @ corbel/frame joint

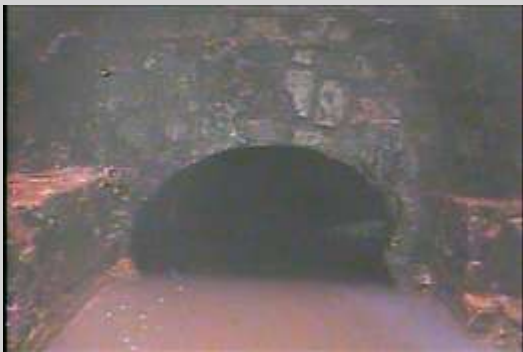
12 O'Clock Outflow

24 in. Circular Gravity Sewer  
Pipe Out @ 12 O'Clock

Pipe Height: **24** (in.) Rod and Bar (Angled)  
Pipe Material: **Clay** ☐ Pipe Lined  
Invert Depth: **15.50** (ft.) Flow Characteristics: **Fast**  
Deposits: ☐ None ☐ Mud ☐ Sludge ☐ Debris ☒ Grease  
Silt Depth: **2** (in.) Deposits Extent: **Light**  
Infiltration: **Evidence** Pipe Seal Cond: **Unknown**

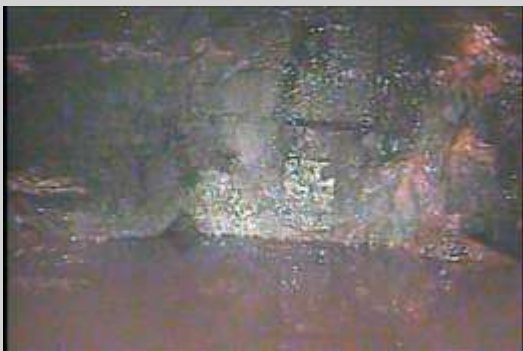
3 O'Clock Inflow

8 in. Circular Gravity Sewer  
Pipe In @ 3 O'Clock

Pipe Height: **8.4** (in.) Rod and Bar (Angled)  
Pipe Material: **Clay** ☐ Pipe Lined  
Invert Depth: **15.15** (ft.) Flow Characteristics: **None**  
Deposits: ☐ None ☐ Mud ☐ Sludge ☒ Debris ☒ Grease  
Silt Depth: **4** (in.) Deposits Extent: **Heavy**  
Infiltration: **None** Pipe Seal Cond: **Unknown**
